Summary report of the turboprop test
chamber acceptance tests conducted on 27
April to 8 May 1964

U. S. NAVAL POSTGRADUATE SCHOOL
Astro/Aeronautical Propulsion Laboratories

SUMMARY REPORT
of the
TURBOPROP TEST CHAMBER ACCEPTANCE TESTS
Conducted on
27 April to 8 May 1964

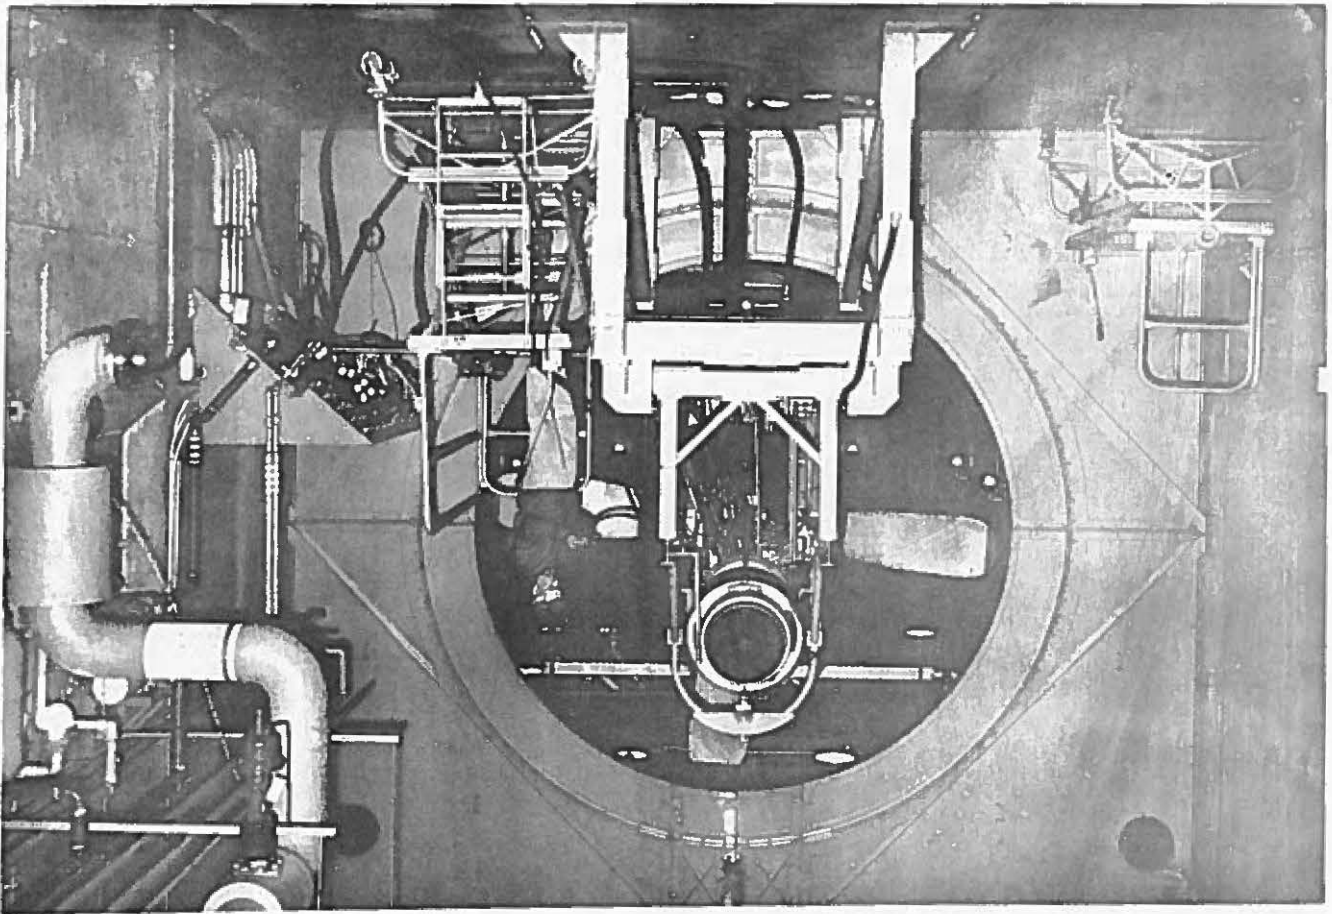
Figure No. 2

During the installation of the engine support stand and the engine, portable work platforms were utilized along both sides of the engine thrust stand, as shown in Figure 2. These units had to be partially disassembled, locked and tied together along the chamber wall during engine operation. Thus any engine adjustment during the tests required that the personnel climb the side of the engine thrust stand and the support stand. This hazardous condition should be eliminated by installation of permanently installed access platforms surrounding the thrust stand. In addition, an expanded metal grating should be placed beneath the thrust stand to protect personnel from falling objects.

Turbojet Test Chamber
(Locking Forward)

- e. Work platforms and ladders should be permanently attached to the engine test stand. The platform should present no undue blockage to the propeller air stream.

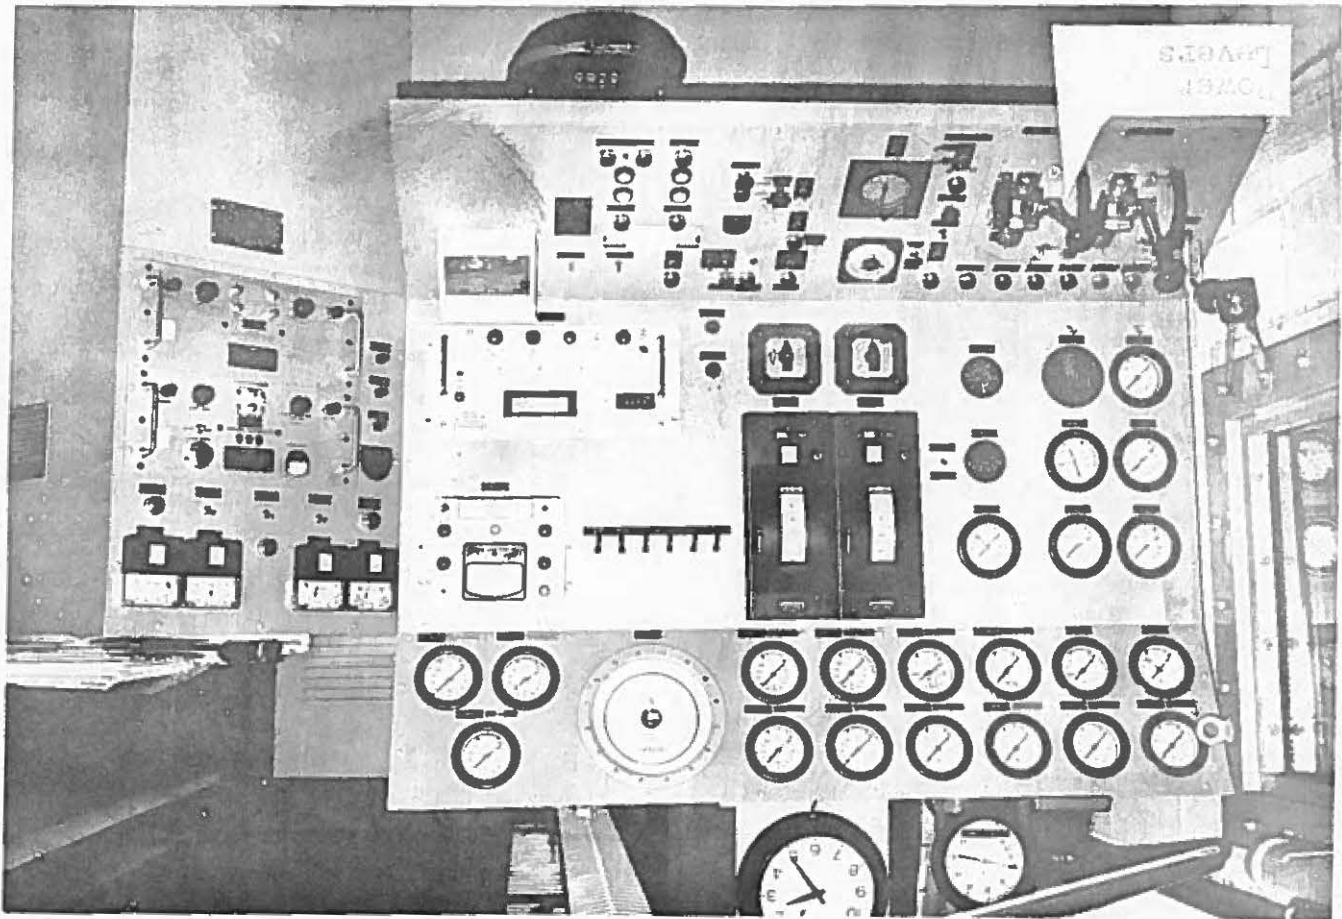
Figure No. 5

(b) The Manual Phase and Trim Assembly, which is an integral part of the propeller synchrophase system, was not initially furnished by the contractor. However, this unit was procured by the contractor along with the synchrophase unit and was installed by the Alameda personnel before the acceptance tests. Both units are shown in Figure 5.

Synchrophaser and Master Term Assembly

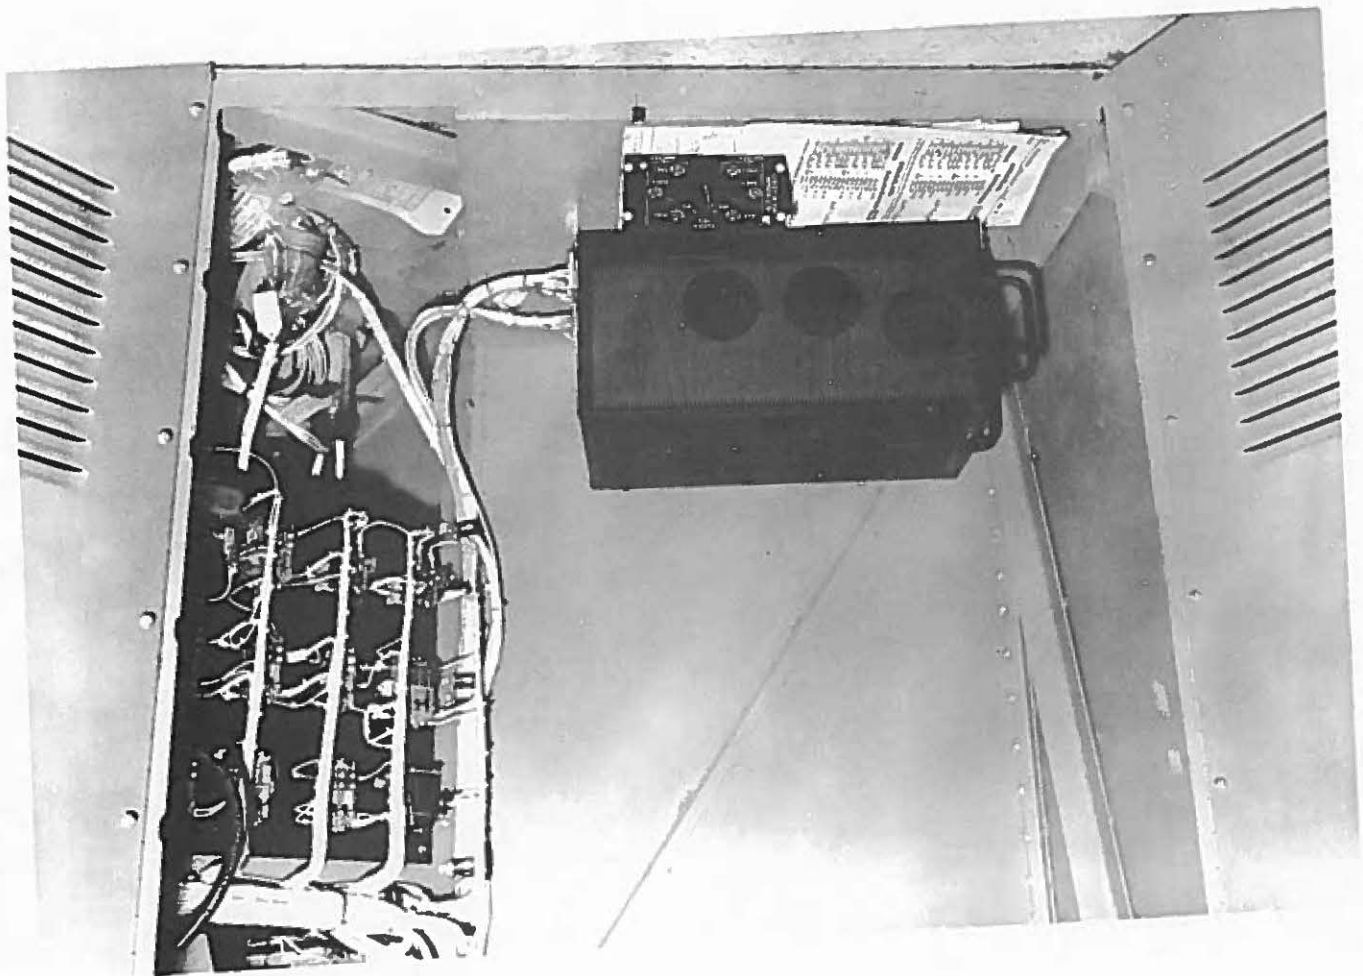
Figure No. 6

(k) No provision was made in the facility electrical system design to provide 208V, 3 phase, 400 cycle power for driving the propeller feather pump motor. A portable power generating unit, shown in Figure 6, was borrowed from NAS Alameda for the duration of the acceptance tests.

Portable Electrical Power Unit (208V-400cps)

- a. A source of 208V - 3 Phase - 400 cps power should be installed in the equipment room.
- b. The oil system should be completely re-designed to conform to the requirements specified in the applicable NAVWEPS publications. Complete control of the system with regard to pressures, temperatures, flow rates, de-airation requirements and oil consumption checks should be made available to the engine operator in the control room. The revised system should be positioned in the original location in the equipment room. The complete heat exchanger complex required for adequate oil temperature control should also be located in the equipment room.

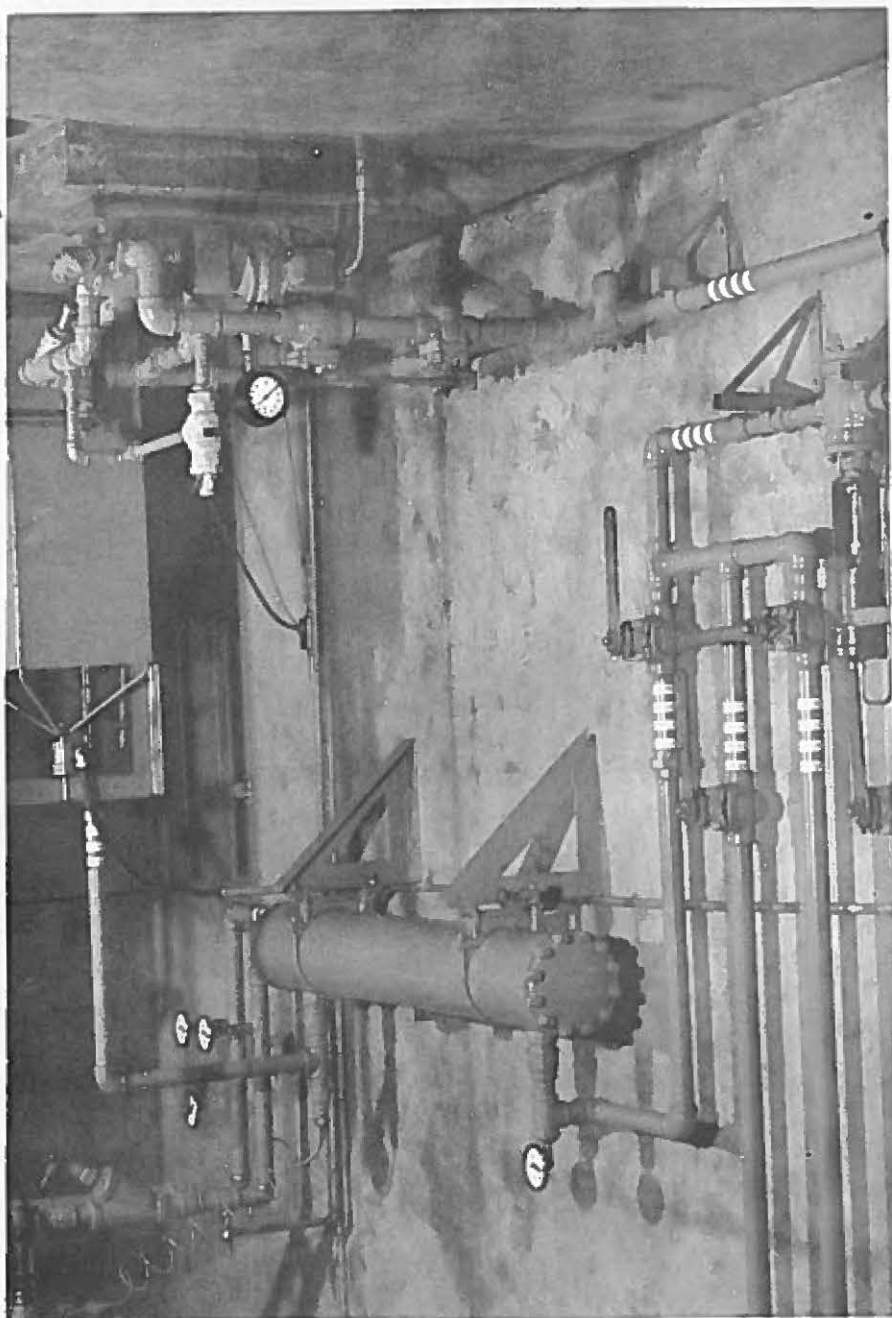
Figure No. 8

(l) The Engine Oil Supply System is shown in Figure 7, and was found to be completely inadequate for use with the T-56 series engine. The Alameda survey revealed that the oil returning from the engine would experience excessive back pressure from the by-passed oil being circulated by the pump. Thus it was necessary to re-route the lines in this area, as shown in Figure 8. This re-arrangement was performed by this activity

(modified pressure regulator and oil return line)

Engine Oil Supply System
